The Bank Job continues

The Friends of Mongarlowe River (FMR) "Bank Job" is project that has improved knowledge, water quality and community engagement and that continues to do so.

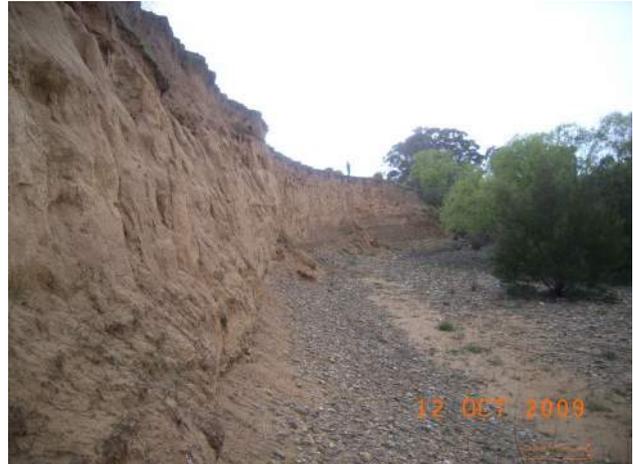
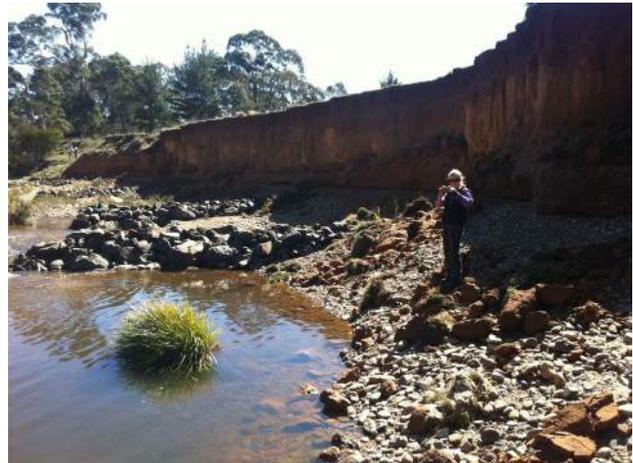
The Bank Job—before—above, and after, below, taken from opposite ends of the eroded bank.

Removing the willow was no easy first task. This was made difficult by the thick blackberry vines guarding its base. The Willow Warriors were called in for expertise in removing the beast. The final design for bank stabilisation involved bringing in rock and making five rock groins. These can be seen in the second photo above.

Eight major rain events later, the rock groins are holding, and sediment has built up behind them. Many of the trees and shrubs we planted are growing well.

The bad news is that the river continues to undercut the bank which has now moved back from the groins. This suggests that the project may have been under-engineered for its task. The battered banks both upstream and downstream of the cliff bank appear to be holding their form through floods. Discussions suggest that we need to evaluate the outcomes of the first project to inform the design of further work to reduce erosion at this site.
